TASK 3.4
LAMB ISLAND DAIRY REMEDIATION
FINAL REPORT

SFWMD Contract No. C-13410

Submitted by:
HSA Engineers & Scientists

March 2006

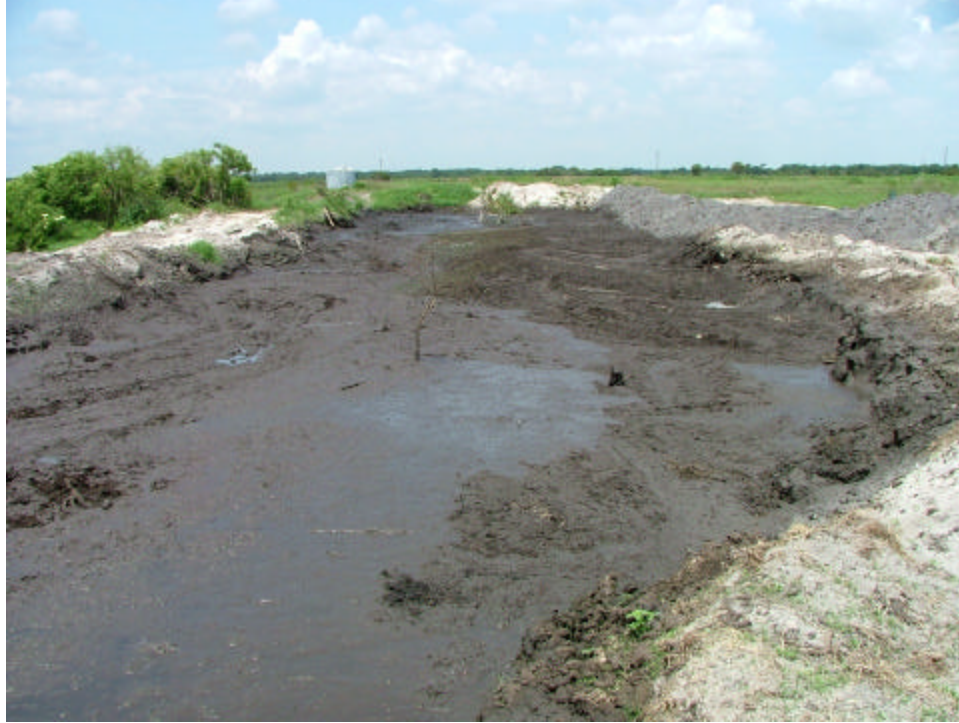
Figure 1. Pond 1

The volume of waste contained in Pond 1 was approximately 8,500 CY. Assuming one cubic yard of wet manure waste is equal to 1,700 pounds (URS 2000), the weight of the residual solids in Pond 1 is approximately 6,600,000 kg. Based on the SFWMD data provided for Pond 1 solids, the average TP concentration is 3,012 mg/kg and the average percent moisture is 71%.

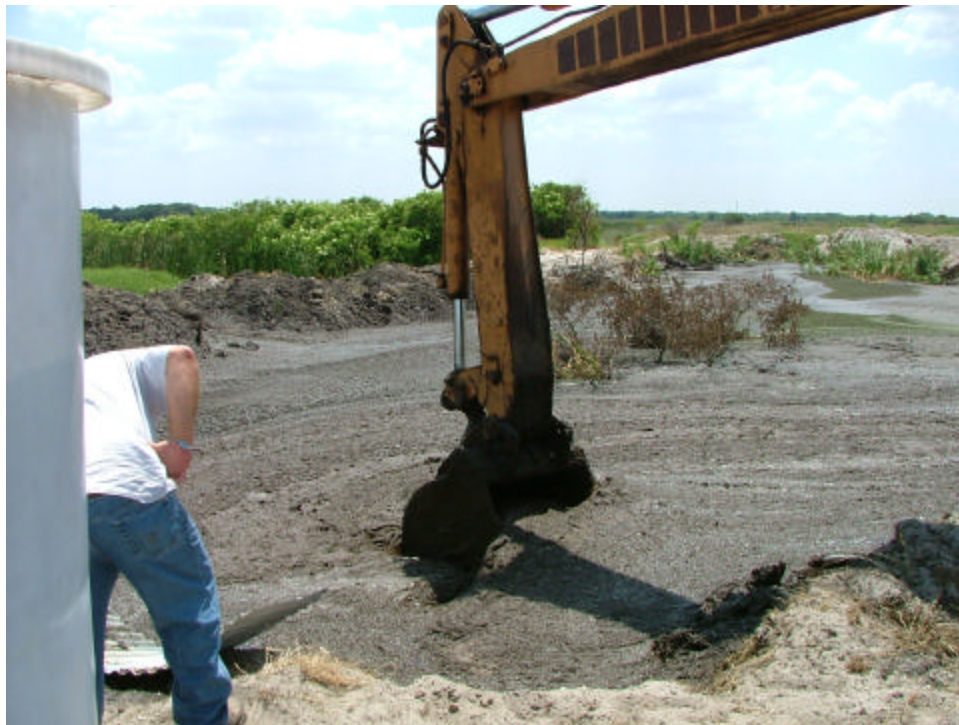
Figure 2. Alum amendment and mixing

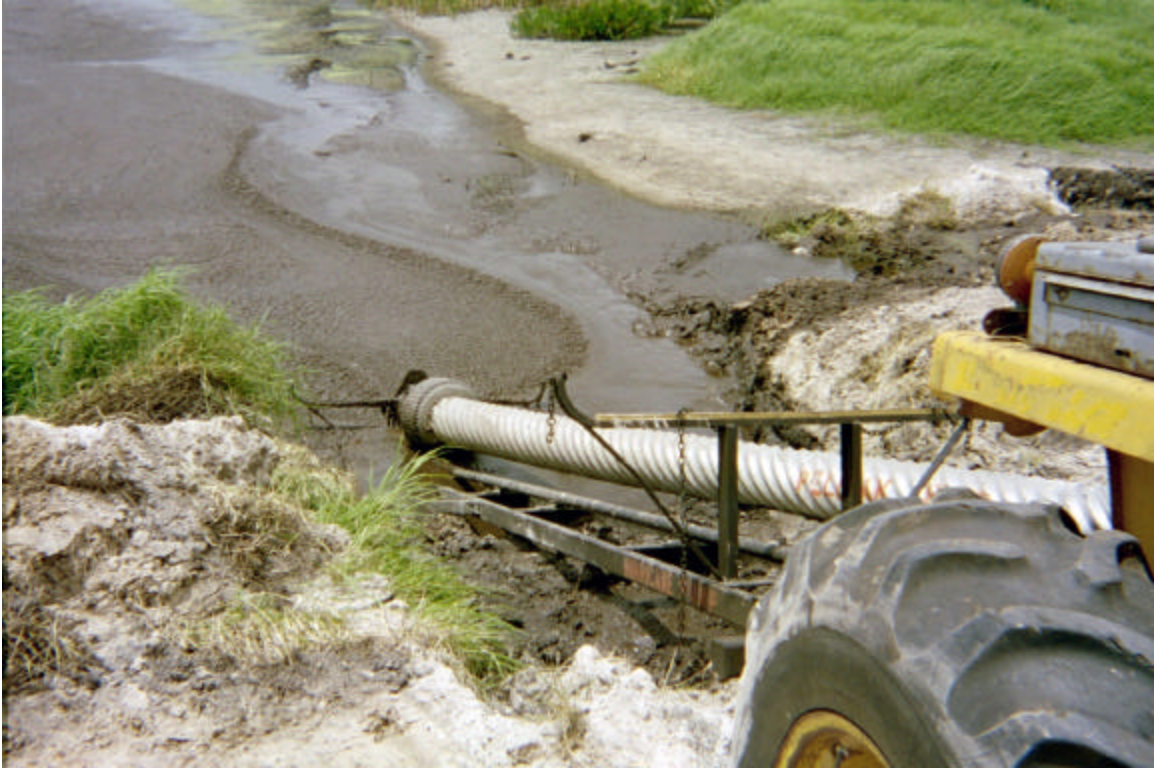
Figure 3. Pumping into Pond 1

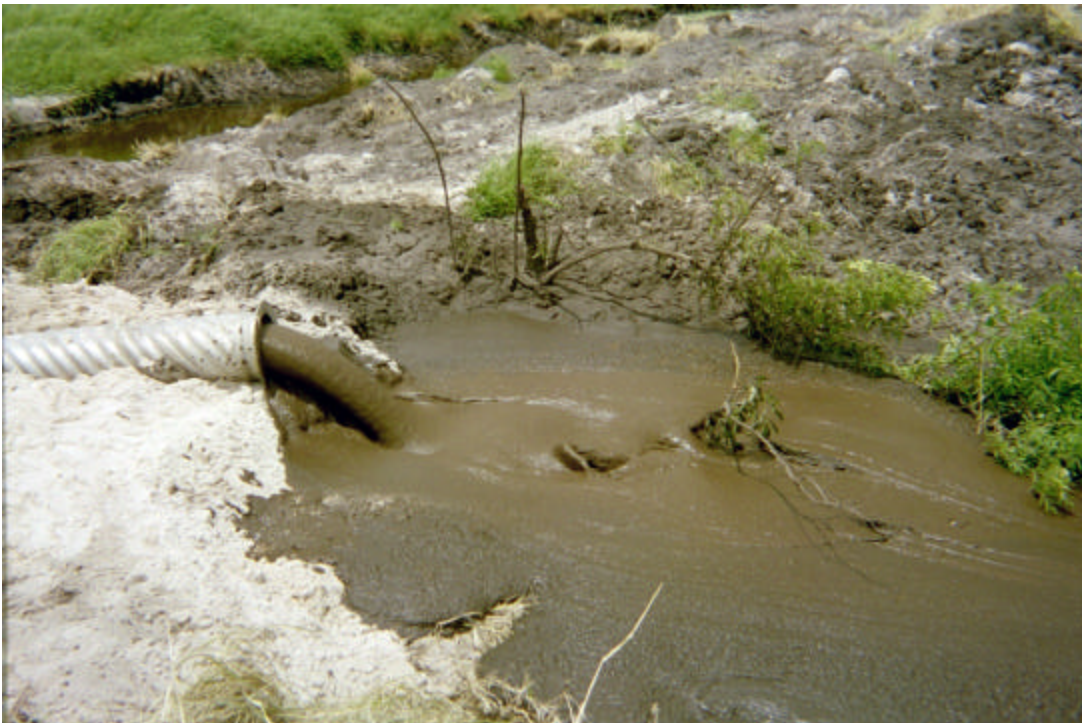
Figure 4. Discharge of pump into Pond 1

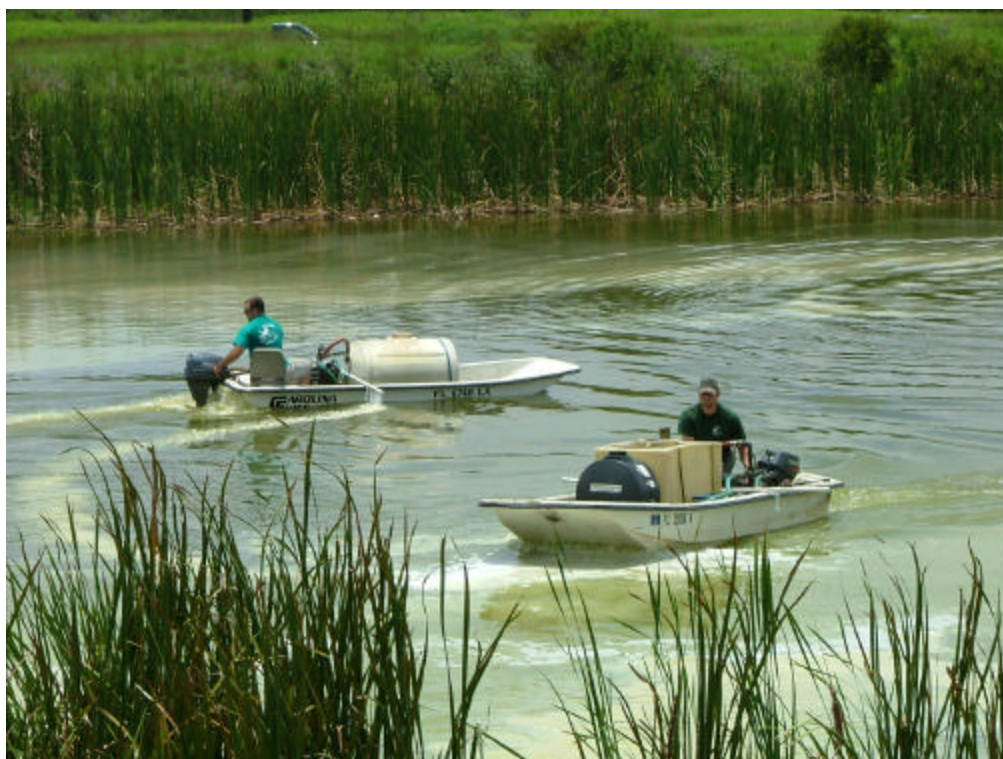
Figure 5. Pond 3 Alum amendment

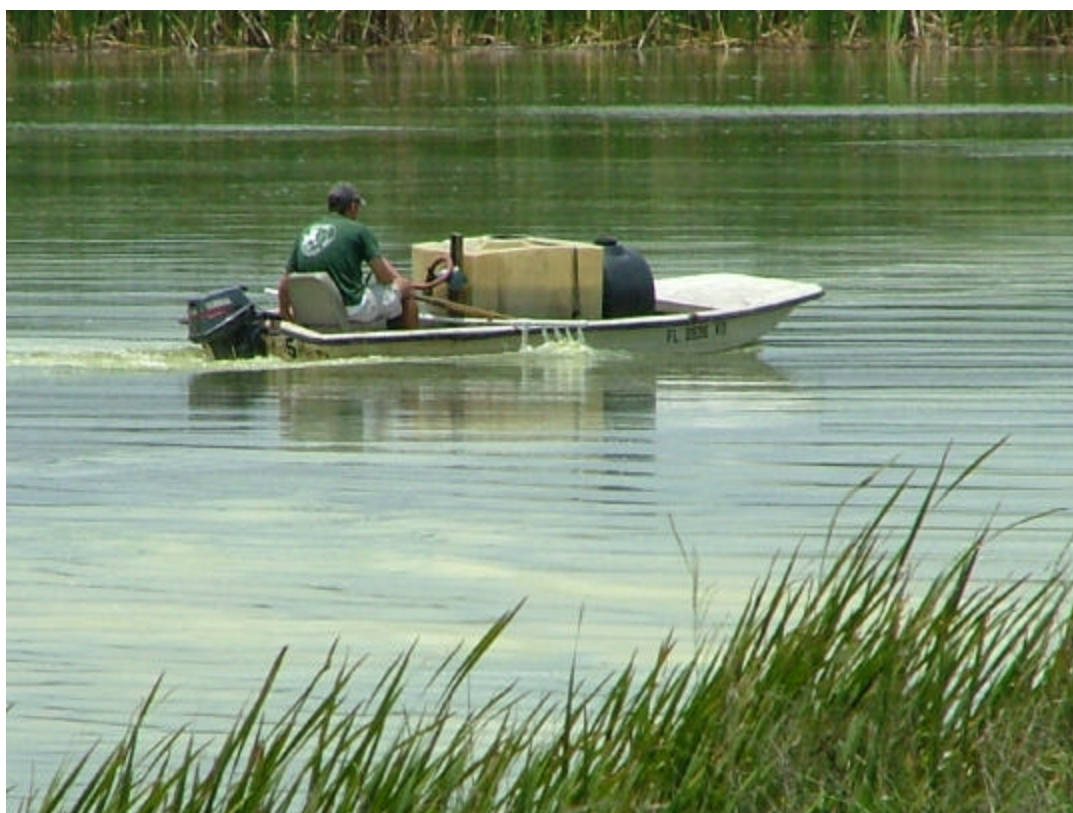
Figure 6. Pond 3 Alum amendment

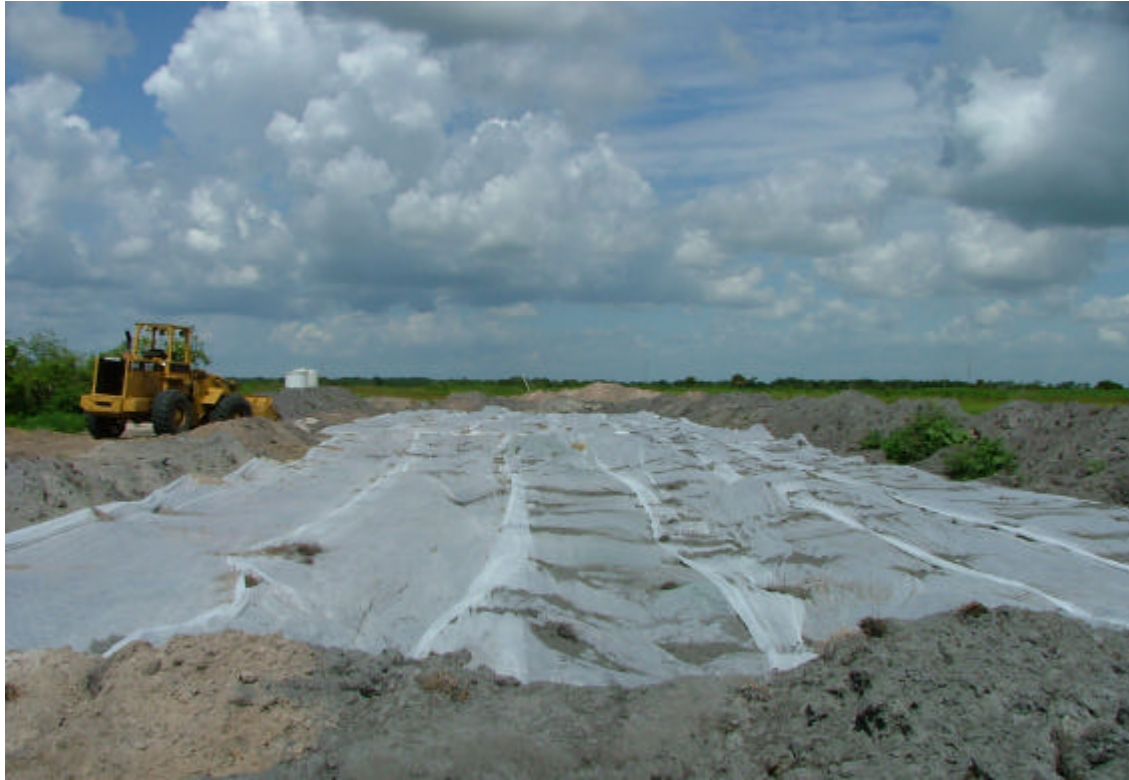
Figure 7. Filter fabric cover over Pond 1
